Title: Stage 1&2 ROAD SAFETY AUDIT

Proposed Large Scale Residential Development (LRD) at Oldcourt LAP Lands, Oldcourt Ballycullen/Bohernabreena Co. Dublin.

Date: June 2024

Report reference: 2291R01

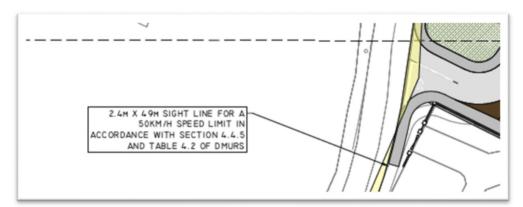
LOCATION Bohernabreena Road.

The sightlines shown on the drawings assume a speed limit of 50km/hr on Bohernabreena Road. The existing speed limit is 60km/hr. A lack of suitable visibility could lead to side-impact or rear-end collisions.

It is recommended that sightlines be provided in accordance wit the speed limit on Bohernabreena Road.

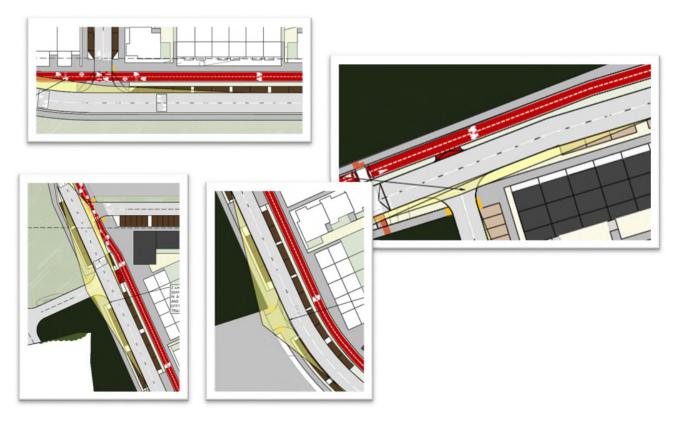
Drawings P211102-PIN-XX-DR-D-110 & 111-SI P02, Sightlines at priority junctions onto Spine Road.

The visibility to the left and/or right for drivers entering onto the Link Road from some internal roads cut through a number (up to 5 no. spaces) of parallel car parking spaces. If these spaces are occupied, especially by a van or similar vehicle then the visibility will not be achieved. This could lead to side-impact or rear-end collisions.

It is recommended that the layout of the parallel parking be modified to achieve the required sightlines.

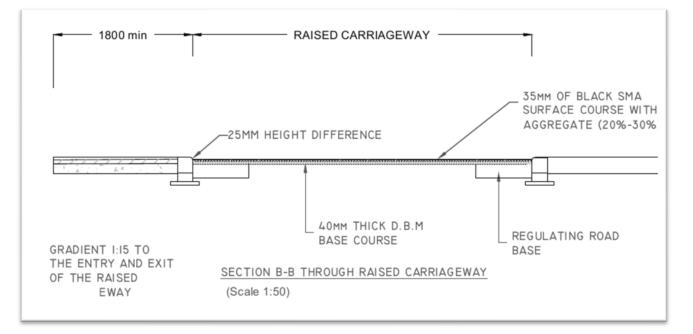
Drawing PIN-ZZ-XX-DR-D-142-SI P01, At Grade Crossing layout.

Section B-B of the at grade crossing layout shows a 25mm kerb upstand. This may lead to trips and falls or inaccessibility for some mobility impaired users.

It is recommended that a flush kerb be provided at the crossing points.

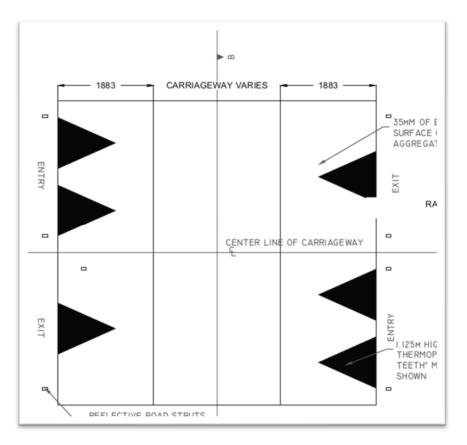
Drawing PIN-ZZ-XX-DR-D-142-SI P01, At Grade Crossing layout.

The at grade crossings extend from kerb to kerb. There is a risk of surface water ponding at the start of the upstream ramp which could lead to loss of traction and loss of control.

It is recommended that gullies be provided upstream of such crossings/raised tables.

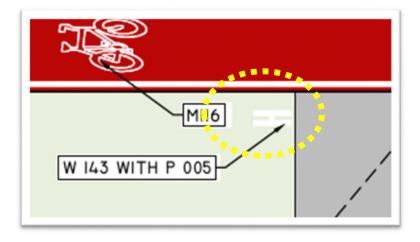
Drawing PIN-ZZ-XX-DR-D-142-SI P01, W143 Sign with P005 supplementary plates.

It is unclear if back to back W143 signs with P005 supplementary plates are proposed. For drivers exiting the side roads the warning signs may be ineffective when located after the hazard which could result in inappropriate approach speeds to the hazard.

It is recommended that advance warning signs be provided a suitable distance in advance of the hazard.

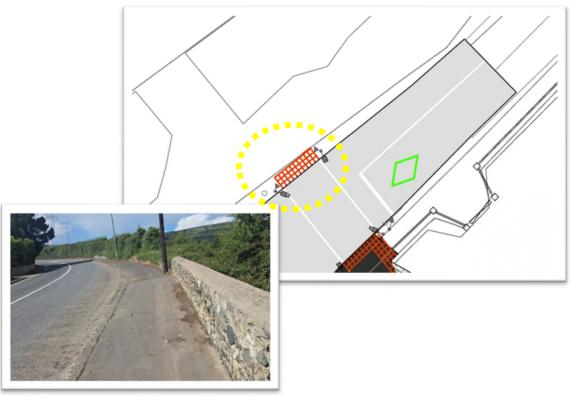
Drawing P211102-PIN-XX-DR-D-150 SI P02, Bohernabreena Road Footpath.

The existing footpath on the western side of Bohernabreena Road is narrow. It is unclear if it is being narrowed further as part of the design. When the traffic signal poles are provided for the signalised junction the footpath may be unpassable for some mobility impaired users (e.g. those travelling to and from the local cemetery). This could lead to pedestrians having to travel on the carriageway where they would be at risk of being struck by passing vehicles. In addition, the crossing will be used by cyclists and bicycles may protrude into the carriageway leading to collisions with passing vehicles.

It is recommended that a suitable effective width of footpath be provided taking into account the set back required for the signal head poles and its use by cyclists waiting to cross.

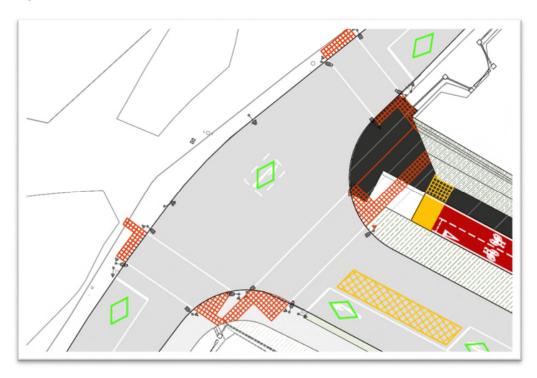
Drawing P211102-PIN-XX-DR-D-150 SI P02, Bohernabreena Road Toucan crossings.

There are two toucan crossings proposed on Bohernabreena Road however there are no areas for cyclists to transition from on-road to off-road except at the crossing. This could lead to cyclists travelling for longer distances on the footpath thereby putting pedestrians at risk or to cyclists mounting/dismounting the high kerbs resulting in loss of control.

It is recommended that a suitable dropped kerb be provided to allow cyclists access to the toucan crossing areas.

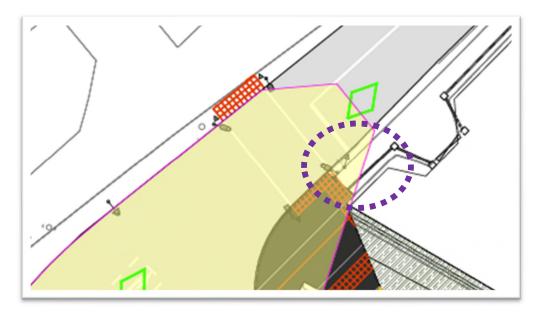
Drawing P211102-PIN-XX-DR-D-150 SI P02, Bohernabreena Road, Junction intervisibility.

The intervisibility line cuts through the boundary wall of the neighbouring property on the northern side of the Bohernabreena Road junction. This wall may be too high to allow visibility which could result in collisions.

It is recommended that suitable intervisibility be provided in both the horizonal and vertical planes.

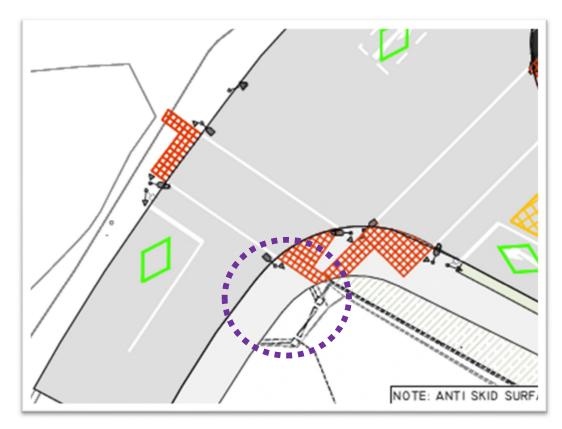
Drawing P211102-PIN-XX-DR-D-150 SI P02, Bohernabreena Road, Windermere Access.

The access to the private residence 'Windermere' to the south of the proposed signalised junction may lead to collisions with the signal pole or to users of the residence not being able to cross to turn right due to the presence of the stop line and lack of visibility to the primary traffic signal relative to the entrance. A lack of access to the new road layout may lead to access/egress movements in conflict with other movements that drivers do not expect at a signalised junction, when they get a green signal, resulting in side impact or rear-end collisions.

Ensure that access and egress can be provided to 'Windermere' without having to disrupt traffic flows. This may require a traffic signal within the property.

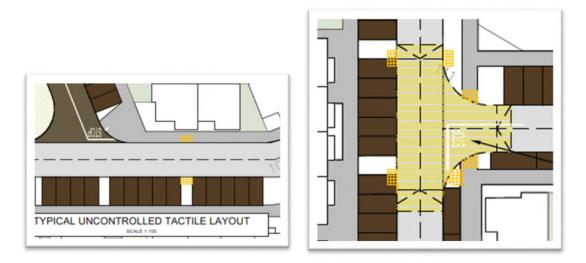
Drawing P211102-PIN-XX-DR-D-161 SI P02, Typical uncontrolled tactile paving.

The drawing shows an uncontrolled pedestrian crossing between two perpendicular car parking spaces. A child could run out between two parked vehicles and a driver would not have time to react given the limited intervisibility.

It is recommended that suitable visibility be provided at uncontrolled pedestrian crossings throughout the scheme.

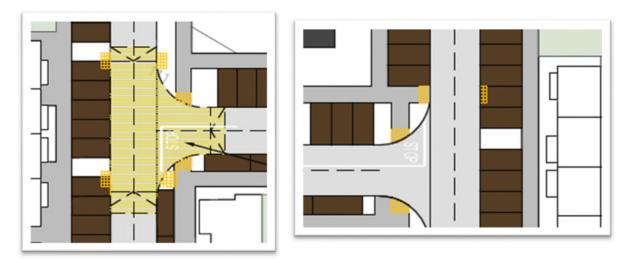
Drawing P211102-PIN-XX-DR-D-101-104 SI P02, Uncontrolled pedestrian crossing locations.

Some uncontrolled crossings are shown to coincide with parking spaces. This could lead to collisions between reversing vehicles and pedestrians.

It is recommended that uncontrolled crossings lead to footpaths only.
