An Arboricultural Assessment of the Tree Vegetation on the 'Oldcourt LRD Lands', Ballycullen & Oldcourt, Dublin 24.

Prepared for: Capami Ltd.

**Prepared by: Felim Sheridan F. Arbor. A, RFS Dip, Nat. Dip & NCH in
Arboriculture**

Date: 8th December 2023

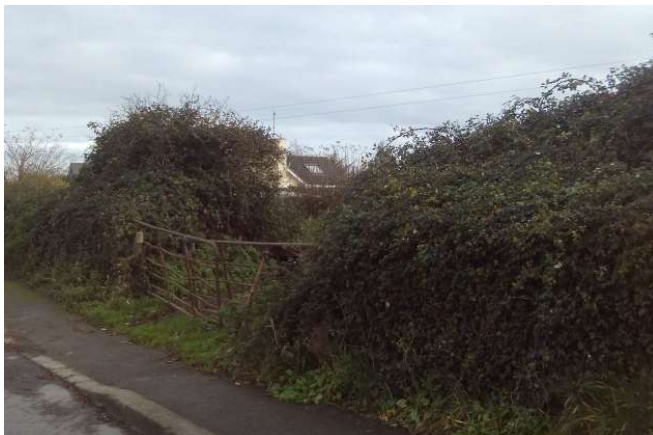
Tree No.	Tree Species	Ht. (m)	Stem Dia. (mm)	Branch Spread (m)	C-Ht. (m)	Age Class	Phys. Con.	Structural Condition Other Comments	Preliminary Recommendation	Remain Contribute in years	Cat. Grade
								N-north S-south E-east W- west Phys.-physiological.	A- average		
		A Condition Assessment of the Tree and Hedge Vegetation on the ‘Oldcourt LRD Lands’ Ballycullen & Oldcourt, Dublin 24. The survey commences at the site entrance off “Bohernabreena Road” and proceeds eastwards in a broadly anti-clockwise direction.									
Hedge No.1	Hawthorn <i>Crataegus monogyna</i> Bramble <i>Rubus fruticosus</i> Blackthorn <i>Prunus spinosa</i>	It extends along the western boundary of the site area with the “Bohernabreena Road” and extends in a north south direction It is of a mature age class in fair/poor condition physiologically and poor condition structurally. It consists of a few isolated clumps of Hawthorn and Blackthorn with large infill areas of Bramble and Dogrose. There is a field access off the “Bohernabreena Road” within this hedge line. It has been allowed to grow unmanaged for some time with scrub, in particular Bramble, encroaching out onto the lands, although it has received cutting from the roadside to contain encroachment out in this direction.

It would benefit from general trimming/ tidying works to control Bramble and from infill planting to create a better structured hedge.	C2

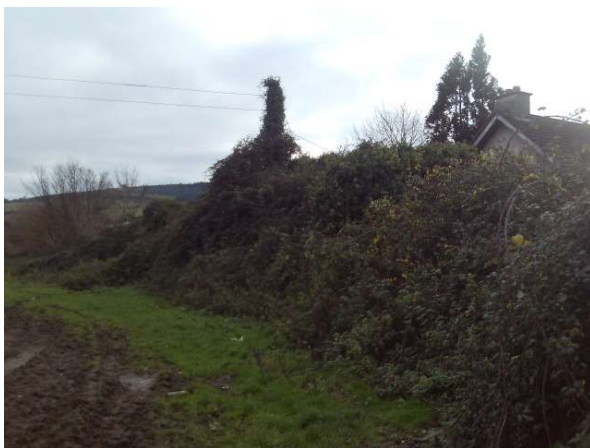
Tree No.	Tree Species	Ht. (m)	Stem Dia. (mm)	Branch Spread (m)	C-Ht. (m)	Age Class	Phys. Con.	Structural Condition Other Comments	Preliminary Recommendation	Remain Contribute in years	Cat. Grade
								N-north S-south E-east W- west Phys.-physiological.	A- average		
Hedge No.2	Hawthorn <i>Crataegus monogyna</i> Bramble <i>Rubus fruticosus</i> Dogrose <i>Rosa canina</i>	It runs at ninety degrees to Hedge No.1 to connect up Hedge No. 3 with the first part forming the boundary with the adjoining property and the latter part forming the boundary between two fields within the site area. It is of a mature age class in poor condition both physiologically and structurally. It consists predominately of Bramble and Dogrose with some Hawthorn and some planting of Norway Maple & Horse Chestnut at the eastern end on the southern side of the fence line. Due to lapsed management, the scrub species in particular Bramble and Dogrose have encroached out creating a broad scrub area along this boundary.

Cut back encroaching hedge species and make safe large size dead/ unstable growth. Carry out pruning and infill planting to create a better structured hedge.	C2

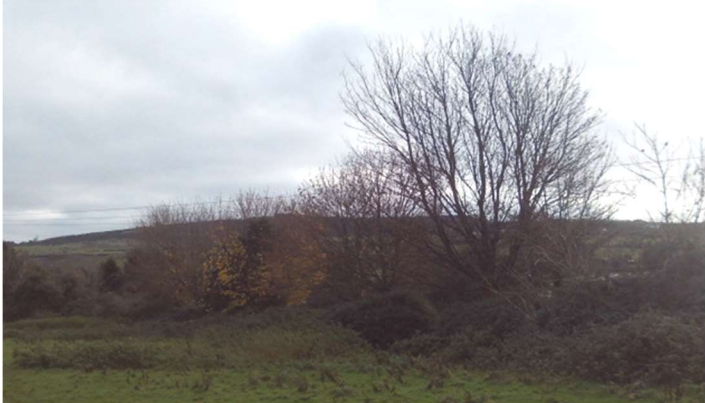
Tree No.	Tree Species	Ht. (m)	Stem Dia. (mm)	Branch Spread (m)	C-Ht. (m)	Age Class	Phys. Con.	Structural Condition Other Comments	Preliminary Recommendation	Remain Contribute in years	Cat. Grade
								N-north S-south E-east W- west Phys.-physiological.	A- average		
		<p>The following trees are located within this hedge line.</p>

Tree No.1	Horse Chestnut <i>Aesculus hippocastanum</i>	6	180	2N 3S 2E 2W	2	Semi Mature	Fair	Fair/Poor It is multiple-stemmed from base and has possibly developed from where a tree has broken out in the past. Access to this tree has been limited due to the dense undergrowth. Some stems would appear to have broken out.	Tidy up the undergrowth and review.	10+	C1
1061	Horse Chestnut <i>Aesculus hippocastanum</i>	8	180	1N 3S 1E 3W	3	Semi Mature	Fair	Fair It has been planted on the outer canopy edge of Tree No.1062 with a slightly asymmetrical crown as a result. Its structure will be affected in the long-term.	Tidy up the area around its base.	20+	C1

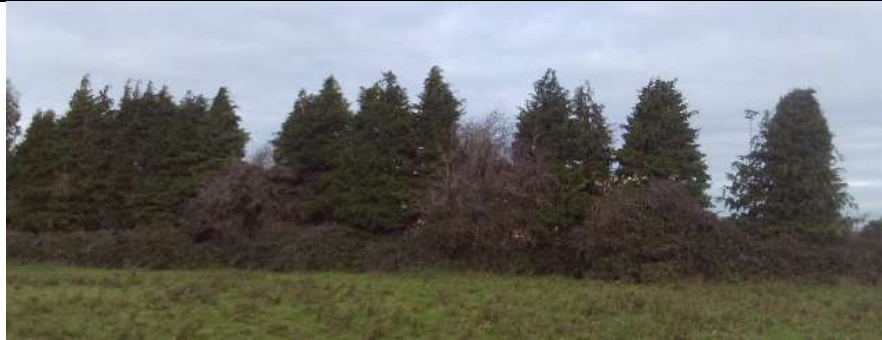
Tree No.	Tree Species	Ht. (m)	Stem Dia. (mm)	Branch Spread (m)	C-Ht. (m)	Age Class	Phys. Con.	Structural Condition Other Comments	Preliminary Recommendation	Remain Contribute in years	Cat. Grade								
								N-north S-south E-east W- west Phys.-physiological.	A- average

<table><tr><th>Ht. (m)</th><th>Stem Dia.(mm)</th><th>Branch Spread (m)</th><th>C-Ht. (m)</th></tr><tr><td>A7</td><td>A200</td><td>A2N, 4S,2E,2W</td><td>A1.5</td></tr></table>		Ht. (m)	Stem Dia.(mm)	Branch Spread (m)	C-Ht. (m)	A7	A200	A2N, 4S,2E,2W	A1.5								
Ht. (m)	Stem Dia.(mm)	Branch Spread (m)	C-Ht. (m)																
A7	A200	A2N, 4S,2E,2W	A1.5																
Hedge No.3	Hawthorn <i>Crataegus monogyna</i> Elder <i>Sambucus nigra</i> Bramble <i>Rubus fruticosus</i> Dogrose <i>Rosa canina</i> Blackthorn <i>Prunus spinosa</i>	It runs in a north-south direction from Hedge No.2 and forms the boundary between two fields within the site area. It is a mature hedge in fair/poor condition physiologically and structurally. It consists of isolated clumps of Hawthorn, Blackthorn and Elder with large infill areas of Bramble and Dogrose. It forms the boundary between two fields and has been allowed to grow unmanaged for some time with scrub species, in particular Bramble and Dogrose dominating and encroaching out to create a broad, scrubby hedgerow. It has also been allowed to grow up tall losing it hedge structure. The original hedge line would appear to have been located on the eastern side of a shallow field drainage ditch.							It would benefit from general tidying works. Trim in encroaching hedge species and make safe large size dead/ unstable growth.	--	C2

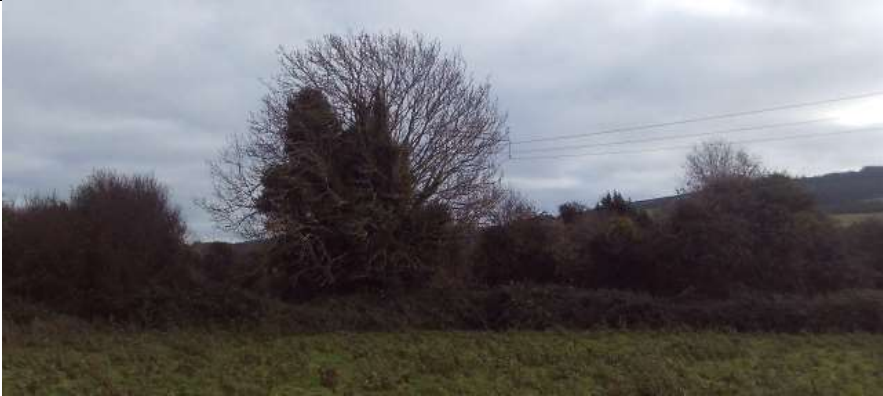
Tree No.	Tree Species	Ht. (m)	Stem Dia. (mm)	Branch Spread (m)	C-Ht. (m)	Age Class	Phys. Con.	Structural Condition Other Comments	Preliminary Recommendation	Remain Contribute in years	Cat. Grade
								N-north S-south E-east W- west Phys.-physiological.	A- average

<p>The following two trees are located within this hedge and are growing up together to form part of the one group canopy formation. As a group they are of same visual prominence within the treescape of this area.</p>									
1070	Ash <i>Fraxinus excelsior</i>	15	320/ 250x2/ 100x3/ 140	6N 6S 5E 2W	2	Mature	Fair	Fair/ Poor It is located within the hedge line and is multiple-stemmed from a height of c.1.2m with an acute union formation between stems. It has possibly been cut / coppiced at this height into the hedge during the past management. The stems have been allowed to grow up tall from this point and are poorly tapered. It forms part of the group canopy formation with Tree No. 1071 with an asymmetrical crown as a result. Heavy Ivy cover on the main trunk extends high up into the crown, increasing the wind sail. Its crown is showing little sign of infection by 'Ash Dieback' at the present time.	Cut Ivy at ground level and tidy up the area around its base.	10+	C2

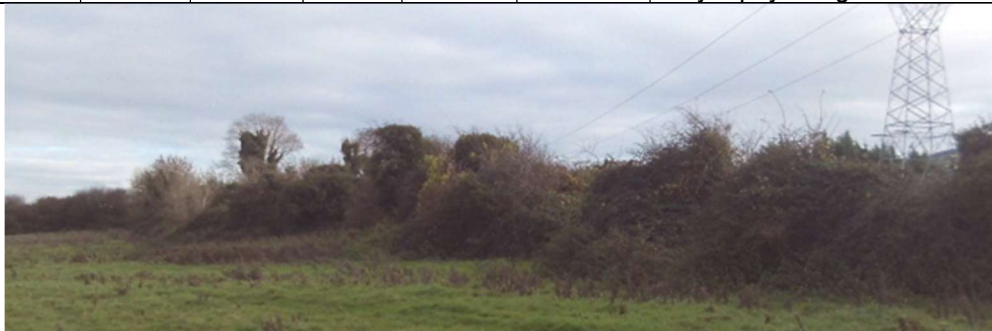
Tree No.	Tree Species	Ht. (m)	Stem Dia. (mm)	Branch Spread (m)	C-Ht. (m)	Age Class	Phys. Con.	Structural Condition Other Comments	Preliminary Recommendation	Remain Contribute in years	Cat. Grade								
								N-north S-south E-east W- west Phys.-physiological.	A- average										
		<div>

</div> <table><tr><th>Ht. (m)</th><th>Stem Dia.(mm)</th><th>Branch Spread (m)</th><th>C-Ht. (m)</th></tr><tr><td>A5</td><td>A130X3</td><td>A3N, A3S</td><td>A0</td></tr></table> <p>The following trees are located within this hedge.</p>							Ht. (m)	Stem Dia.(mm)	Branch Spread (m)	C-Ht. (m)	A5	A130X3	A3N, A3S	A0			
Ht. (m)	Stem Dia.(mm)	Branch Spread (m)	C-Ht. (m)																
A5	A130X3	A3N, A3S	A0																
1072	Ash <i>Fraxinus excelsior</i>	11	320 340	5N 6S 6E 4W	2	Early Mature	Fair	Fair A single stem tree growing out of a small hedgerow bank. It has a pronounced lean to the north before straightening up. The crown develops at c2.5m and is showing little sign of infection by ‘Ash Dieback’ at the present time. There is soil erosion caused by livestock around its base.	No work required at the present time.	10+	C2								
1073	Ash <i>Fraxinus excelsior</i>	10	280	4N 4S 3E 3W	1.5	Early Mature	Fair / Poor	Poor A single stem tree to c.3m where it divides into two co-dominant stems. There is very heavy Bramble and Ivy growth around the base limiting the visual inspection. Heavy Ivy cover extends	Cut back encroaching Bramble and cut Ivy at ground level.	10+	C2

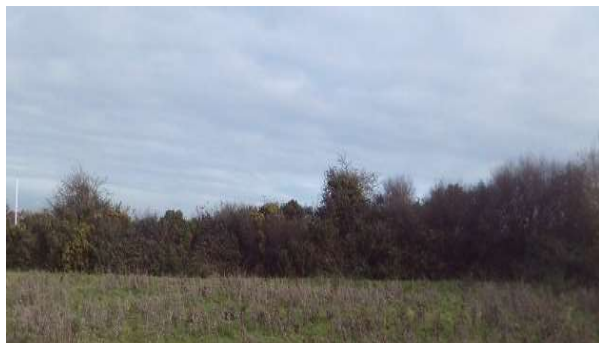
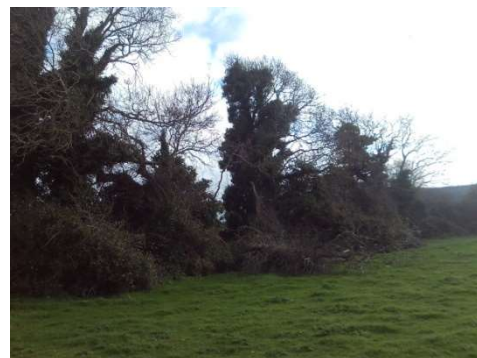
Tree No.	Tree Species	Ht. (m)	Stem Dia. (mm)	Branch Spread (m)	C-Ht. (m)	Age Class	Phys. Con.	Structural Condition Other Comments	Preliminary Recommendation	Remain Contribute in years	Cat. Grade							
								N-north S-south E-east W- west Phys.-physiological.	A- average									
				1W				under the power lines and has no long-term potential in this location. It has been suppressed by heavy Ivy growth.										
Hedge No.5	<p>Gorse <i>Ulex europaeus</i> Blackthorn <i>Prunus spinosa</i> Dogrose <i>Rosa canina</i> Bramble <i>Rubus fruticosus</i> Hawthorn <i>Crataegus monogyna</i> Elder <i>Sambucus nigra</i> Ash <i>Fraxinus excelsior</i></p>	<p>It runs at ninety degrees to Hedge No.4 in a north-south direction at the eastern end of the site area forming the site boundary with the adjoining lands to the east.</p> <p>It is a mature age class in fair condition physiologically and fair/poor condition structurally. It consists of isolated clumps of Hawthorn with large infill areas of Blackthorn and Gorse with Bramble and Dog Rose colonising the base. It has been allowed to grow unmanaged for some time with the scrub species, in particular Gorse, Bramble and Dogrose dominating to create a broad, scrubby hedgerow.</p> <table><tr><th>Ht. (m)</th><th>Stem Dia.(mm)</th><th>Branch Spread (m)</th><th>C-Ht. (m)</th></tr><tr><td>A5</td><td>A -</td><td>A4E, A4W</td><td>A0</td></tr></table> <div>

</div> <p>The following trees are located at the southern end of this hedge.</p> <p>It consists of six trees which have grown up over the line of the hedge and they form a prominent tree line in the local treescape. Heavy Ivy cover is extending high into their crowns increasing their crown wind sail. There are</p>						Ht. (m)	Stem Dia.(mm)	Branch Spread (m)	C-Ht. (m)	A5	A -	A4E, A4W	A0	<p>The hedge would benefit from general tidying works and the trimming in of encroaching hedge species. Carry out pruning and infill planting to create a better structured hedge.</p>		C2
Ht. (m)	Stem Dia.(mm)	Branch Spread (m)	C-Ht. (m)															
A5	A -	A4E, A4W	A0

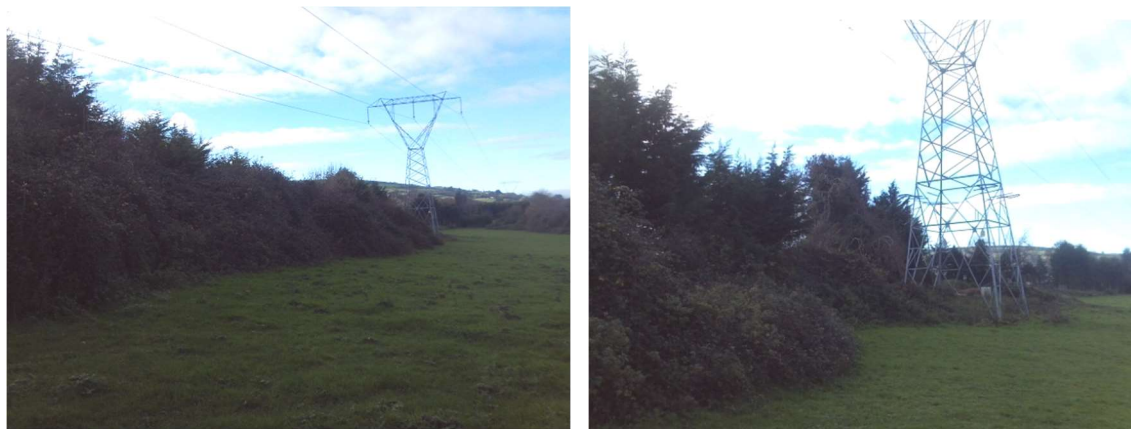
Tree No.	Tree Species	Ht. (m)	Stem Dia. (mm)	Branch Spread (m)	C-Ht. (m)	Age Class	Phys. Con.	Structural Condition Other Comments	Preliminary Recommendation	Remain Contribute in years	Cat. Grade			
								N-north S-south E-east W- west Phys.-physiological.	A- average					
	<i>Rubus fruticosus</i> Dogrose <i>Rosa canina</i> Blackthorn <i>Prunus spinosa</i>	have been allowed to encroach out due to lapsed management creating a scrubbier hedge. The hedge runs underneath the overhead power lines for most of its length and has been cut down to maintain clearance.						<div><div><div>Ht. (m)</div><div>Stem Dia.(mm)</div><div>Branch Spread (m)</div><div>C-Ht. (m)</div></div><table><tr><td>A4</td><td>A12OX2 stems</td><td>A2N, 2S</td><td>--</td></tr></table></div> <div>

</div>	A4	A12OX2 stems	A2N, 2S	--	This hedge would also benefit from the removal of the Leyland Cypress.	
		A4	A12OX2 stems	A2N, 2S	--									
Tree Line No. 2	Golden Leyland Cypress <i>Cupressocypariss leylandii</i> cv	It runs the full length of Hedge No.6 on its southern side. It consists of a line of early mature trees in fair condition physiologically and fair/poor condition structurally. Originally most likely planted as a screen hedge, it has been allowed to grow to its current height where it is overcrowding /suppressing out the original hedge. The line is not continuous along its length with some gaps where trees have been removed or failed naturally. At the eastern end, the section which runs underneath the overhead utility lines has been heavily cut back to maintain clearance and this has further impact of quality and structure. Ground levels have been altered on the northern side on this hedge and tree line.						Remove soil and vegetation from around the base and restore soil level to original ground level. Tidy up undergrowth	10+	C2

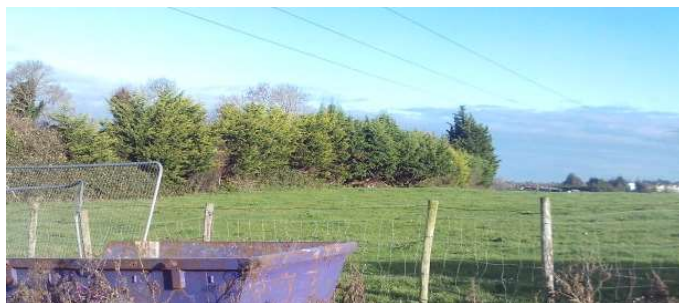
Tree No.	Tree Species	Ht. (m)	Stem Dia. (mm)	Branch Spread (m)	C-Ht. (m)	Age Class	Phys. Con.	Structural Condition Other Comments	Preliminary Recommendation	Remain Contribute in years	Cat. Grade
								N-north S-south E-east W- west Phys.-physiological.	A- average		
		Ht. (m)	Stem Dia.(mm)	Branch Spread (m)		C-Ht. (m)					
		A8	A180	A2N, 2S,2E,2W		A1.5

The following trees are located within this hedge/tree line.									
1080	Golden Leyland Cypress <i>Cupressocypariss leylandii cv</i>	15	380/ 340/ 200	5N 4S 3E 4W	2	Early Mature	Fair / Good	Fair/Poor It is growing up with Tree No. 1081 with a combined canopy. It divides at c.1m into three stems with a broad union formation. Ground levels have been raised on the northern side which may have impacted the root zone. There are broken branches in the crown and there are various pieces of railings / fence sections around the base.	Remove railings / fencing from around the base Restore soil level to original ground level.	10-20	C1

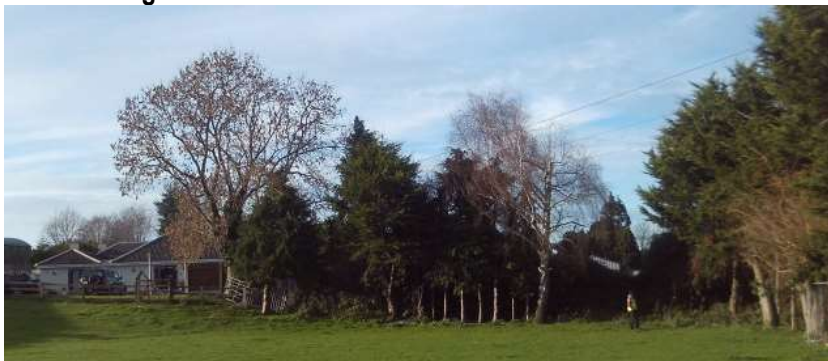
Tree No.	Tree Species	Ht. (m)	Stem Dia. (mm)	Branch Spread (m)	C-Ht. (m)	Age Class	Phys. Con.	Structural Condition Other Comments	Preliminary Recommendation	Remain Contribute in years	Cat. Grade
								N-north S-south E-east W- west Phys.-physiological.	A- average		
		The following trees are located within this Tree Line No.4

1413	Birch <i>Betula sp.</i>	12	500	N4 S5 E5 W4	2	Mature	Fair	Fair / Poor It is located within close proximity to the overhead utility lines and has been heavily cut back on the east side as a result of the utility lines which has impacted greatly on its structure and appearance.	It will require ongoing management in order to maintain clearance with overhead utility line.	10+	C1
1414	Lawson Cypress <i>Chamaecyparis lawsoniana</i>	9	330	N3 S2 E2 W2	1	Early Mature	Fair/ Good	Fair It is located at the western end of the tree line with an independent crown formation. The lower branches have been pruned/ removed in the past in order to raise up its crown.	Requires no work at the present time.	20+	C1

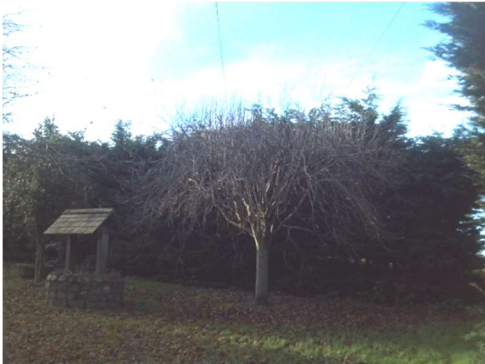
Tree No.	Tree Species	Ht. (m)	Stem Dia. (mm)	Branch Spread (m)	C-Ht. (m)	Age Class	Phys. Con.	Structural Condition Other Comments	Preliminary Recommendation	Remain Contribute in years	Cat. Grade
								N-north S-south E-east W- west Phys.-physiological.	A- average		
				W2				its lower branches have been removed previously. It forms a twin-stemmed tree from base.			
1430	Whitebeam <i>Sorbus Aria</i>	7	330	N4 S5 E4 W4	2	Early Mature	Fair/ Good	Fair It is located within close proximity to the overhead utility lines and its height and size has been reduced as a result with a dense multiple-stemmed crown developing from the pruning points.	It will require further maintenance due to its position underneath the overhead utility lines. It may be considered for removal as part of management.	10+	C1
Hedge No.8	Leyland Cypress <i>Cuprocyparis leylandii</i>	It extends in a north-south direction along the west boundary of this garden with the neighbouring property. It is of an Early Mature age class in fair condition physiologically and structurally. It has been trimmed previously due to the overhead utility lines and to contain its size. It has a reasonably good hedge structure and is of value for screening within this area.							It will require ongoing maintenance / management in order to contain.		C2

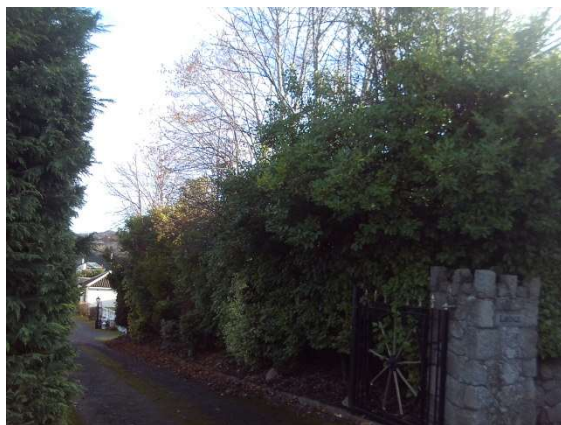
Tree No.	Tree Species	Ht. (m)	Stem Dia. (mm)	Branch Spread (m)	C-Ht. (m)	Age Class	Phys. Con.	Structural Condition Other Comments	Preliminary Recommendation	Remain Contribute in years	Cat. Grade
								N-north S-south E-east W- west Phys.-physiological.	A- average		
		Ht. (m)	Stem Dia.(mm)	Branch Spread (m)	C-Ht. (m)						
		9	180	3E, 2W	0						
Hedge No.9	Griselinia Ornamental Shrubs <i>Griselinia sp.</i>	It runs in an east to west direction along the southern side of the entrance avenue along the boundary with the neighbouring property. It is of a Mature age class in Fair condition physiologically and structurally. It consists of Griselinia along with ornamental shrubs and has been clipped/ maintained as a high formal hedge and is of value for screening within this area.

Continue present maintenance.	C2	
		Ht. (m)	Stem Dia.(mm)	Branch Spread (m)	C-Ht. (m)						
		4	60	1E, 1W	0

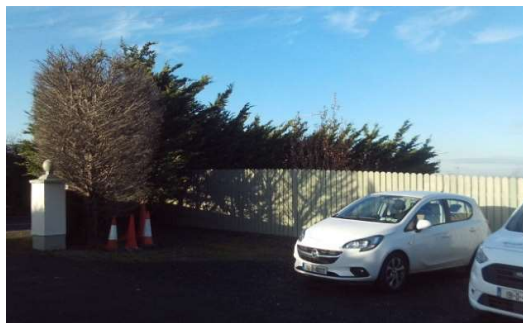
Tree No.	Tree Species	Ht. (m)	Stem Dia. (mm)	Branch Spread (m)	C-Ht. (m)	Age Class	Phys. Con.	Structural Condition Other Comments	Preliminary Recommendation	Remain Contribute in years	Cat. Grade
								N-north S-south E-east W- west Phys.-physiological.	A- average		
								height of c.3m up with an acute union formation between stems and this may develop into a structural weakness.	It could be considered for removal as part of the selective thinning.		
Hedge No.10	Lawson Cypress Variegated <i>Chamaecyparis lawsoniana</i> <i>'veriegata'</i>	It is located to the left of the entrance into 'Beasley Lodge' and extends along the front boundary wall with the public road. It is of an early-mature age class in fair condition both physiologically and structurally. It has been clipped/ maintained as a low formal hedge. Three of the trees at the southern end are in decline or are dead; however the cause of this is not fully known.							Remove the dead trees and prune the remaining trees to improve their shape/ balance.		
<table><tr><th>Ht. (m)</th><th>Stem Dia.(mm)</th><th>Branch Spread (m)</th><th>C-Ht. (m)</th></tr><tr><td>6</td><td>100</td><td>2E, 1W</td><td>0</td></tr></table>		Ht. (m)	Stem Dia.(mm)	Branch Spread (m)	C-Ht. (m)	6	100	2E, 1W			0
Ht. (m)	Stem Dia.(mm)	Branch Spread (m)	C-Ht. (m)								
6	100	2E, 1W	0

Shrub Border No.1	Mixed Ornamental Shrubs	It is located between the entrance to 'Beasley Lodge' and the entrance into the cemetery. It consists of some formal planting on either side of the driveway. It has been trimmed and maintained as a formal shrub border.							Continue present maintenance.	C2

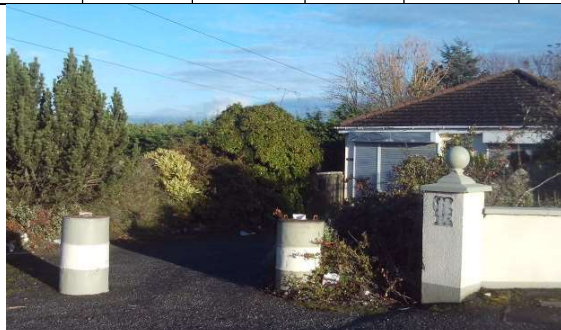
Tree No.	Tree Species	Ht. (m)	Stem Dia. (mm)	Branch Spread (m)	C-Ht. (m)	Age Class	Phys. Con.	Structural Condition Other Comments	Preliminary Recommendation	Remain Contribute in years	Cat. Grade	
								N-north S-south E-east W- west Phys.-physiological.	A- average

Hedge No.11	Leyland Cypress <i>Cuprocyparis leylandii</i>	<p>It is located along the north side of the boundary wall with the Cemetery grounds.</p> <p>It is of a mature age class in poor condition both physiologically and structurally.</p> <p>It consists of vegetation growing within a confined space between the boundary wall and the buildings.</p> <p>It contains some cut down Leyland Cypress trees at the eastern end with mainly naturally self-generating scrub species such as Elder, Bramble and Clematis. It has been trimmed on the cemetery side in order to contain.</p> <p>This is not an ideal location for vegetation; however it is of some value for screening.</p>							Continue present maintenance.	C2

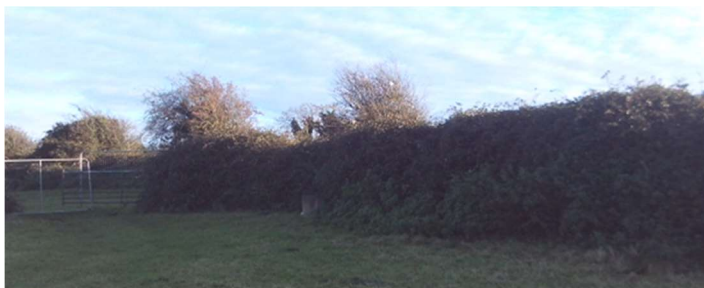
Tree No.	Tree Species	Ht. (m)	Stem Dia. (mm)	Branch Spread (m)	C-Ht. (m)	Age Class	Phys. Con.	Structural Condition Other Comments	Preliminary Recommendation	Remain Contribute in years	Cat. Grade
								N-north S-south E-east W- west Phys.-physiological.	A- average		
		Ht. (m)	Stem Dia.(mm)	Branch Spread (m)	C-Ht. (m)						
		A4	--	A4	--						
Hedge No.12	Bramble <i>Rubus fruticosus</i>	It runs to the back of the yard in an eastwards direction and forms the boundary between the paddock and the adjoining access track to the other fields. It is of a mature age class in fair/poor condition physiologically and in poor condition structurally. It consists of predominately Bramble and is growing up through the fencing wire along with some seedling's trees.

It would benefit from general tidying works and infill planting to improve its diversity, continuity and structure.	C2	
		Ht. (m)	Stem Dia.(mm)	Branch Spread (m)	C-Ht. (m)

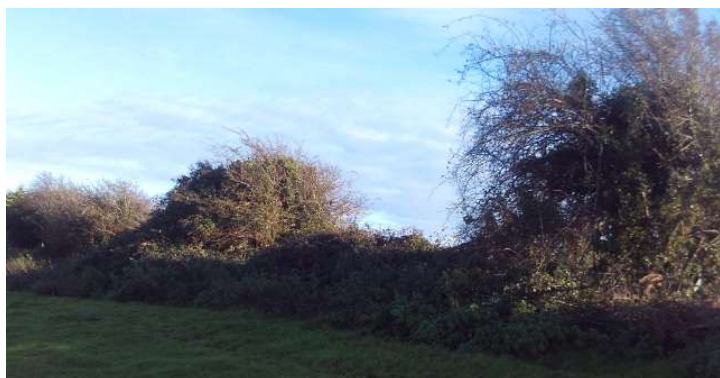
Hedge No.14	Hawthorn <i>Crataegus monogyna</i> Elder <i>Sambucus nigra</i> Bramble <i>Rubus fruticosus</i> Dogrose <i>Rosa canina</i>	<p>It extends in an eastward's direction from the boundary wall of the cemetery and forms the boundary between the fields to the north and the cemetery lands to the south.</p> <p>It is of a mature age class in fair condition physiologically and in fair/ poor condition structurally. It consists of isolated clumps of Hawthorn and Elder with large infill areas of Bramble and Dogrose. It is losing its hedge structure due to lapsed management with hedge species such as Bramble and Dogrose encroaching out onto the lands creating a broad scrubby hedge. The hedge plants are also structurally poor due to lapsed management.</p>

Make safe large dead/ unstable growth and carry out general tidging works. Trim in encroaching hedge species.	C2

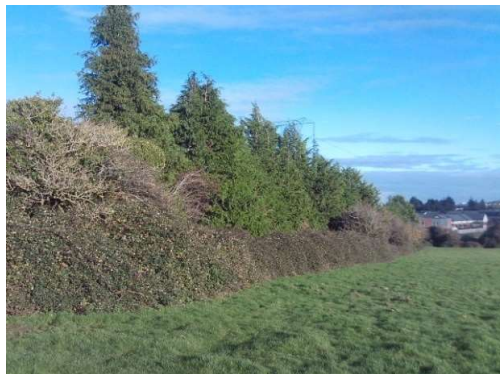
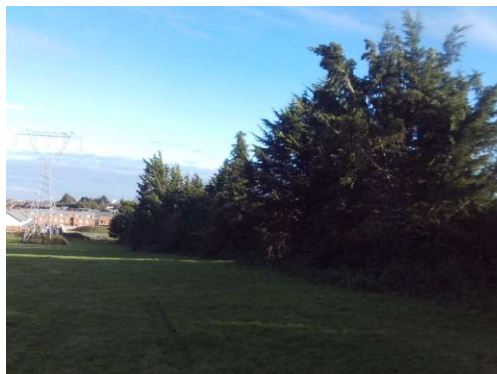
Tree Line No. 5	Leyland Cypress	A. 10	A.340	A. 4N 3S	A.1	Early Mature	Fair	Poor Planted on the northern side of Hedge No.15 and it extends in a broadly east to west direction along	Control Bramble and other encroaching hedge species.	10+	C1

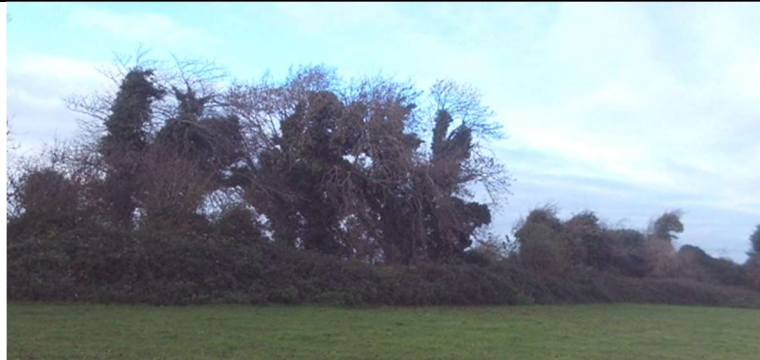
<p>The following trees are located within this hedge.</p>									
0882	Ash <i>Fraxinus excelsior</i>	13	400/ 150/ 160/ 500	5N 3S 5E 5W	3	Mature	Fair	Fair/Poor A multi stem tree from near ground level, with an acute union formation between the stems. Heavy Ivy growth extends high into the crown, increasing the wind sail. Heavy Bramble growth around the base has limited inspection.	Cut Ivy at ground level and tidy up undergrowth.	10+	C2
0883	Ash <i>Fraxinus excelsior</i>	7	200/ 210	3N 3S 0E 4W	1	Early Mature	Fair	Fair / Poor A twin stem tree dividing near ground level with an acute union formation between stems. It is being suppressed by the larger Tree No. 0882. It has been drawn up for light and it is being suppressed by Ivy.	Cut Ivy at ground level.	10+	C2

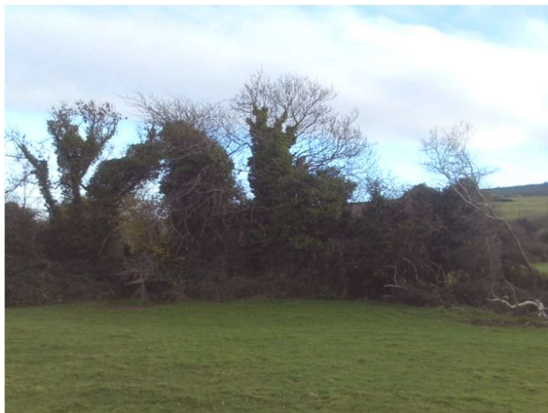
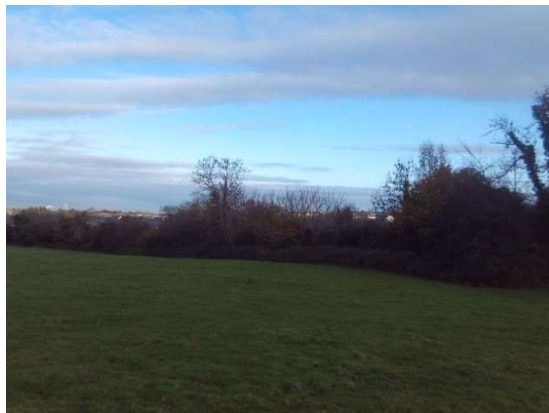
</div> <table><tr><th>Ht. (m)</th><th>Stem Dia.(mm)</th><th>Branch Spread (m)</th><th>C-Ht. (m)</th></tr><tr><td>A6</td><td>-</td><td>A5</td><td>-</td></tr></table> <p>The following trees are located within this hedge.</p>						Ht. (m)	Stem Dia.(mm)	Branch Spread (m)	C-Ht. (m)	A6	-	A5	-		
Ht. (m)	Stem Dia.(mm)	Branch Spread (m)	C-Ht. (m)														
A6	-	A5	-														
0919	Ash <i>Fraxinus excelsior</i>	16	260/ 240/ 240/ 220/ 220/ 190/ 190/	6N 5S 7E 2W	2	Mature	Poor	Poor It is multiple-stemmed from base and is located on the southern side of the drainage ditch. Its crown is showing signs of decline / dieback throughout with a lot of deadwood present. A lot of soil erosion has been caused by the livestock sheltering/ grazing within this area. This tree has started to fall apart with a number of stems breaking out and hung up on surrounding trees and hedge.	I would recommend its removal as part of management.	<10	U

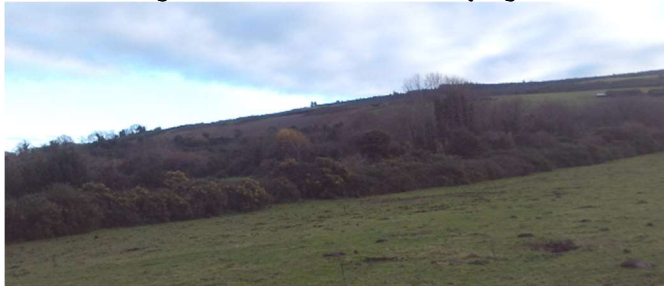
Trim in all encroaching hedge species. Remove some of the Bramble to allow for replanting and to allow the development of a more structured hedge.	C2

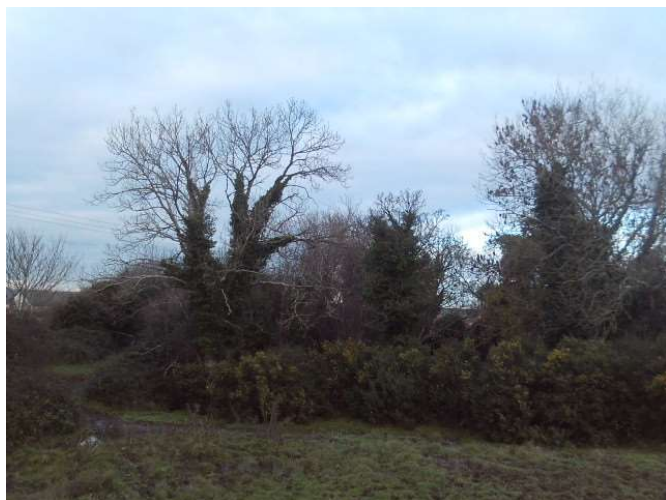
The following trees are located within this hedge.																			
0942	Sycamore <i>Acer pseudoplatanus</i>	11	250/ 200/ 180	3N 4S 5E	1.5	Early Mature	Fair	Fair It is growing on the hedgerow bank and wire has been attached to the lower trunk. It subdivides	Cut Ivy at ground level. Tidy up the area around its base	20+	B1

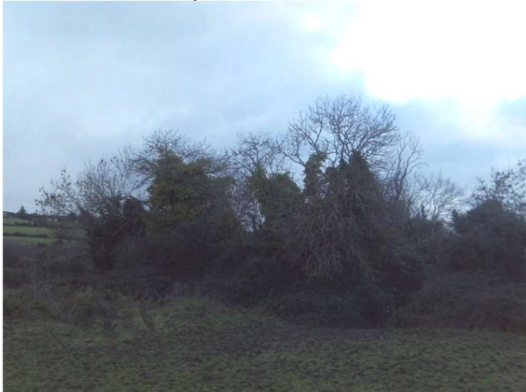
<p>Restrict access by grazing animals.</p> <p>Make safe dense / unstable growth.</p> <p>Remove barbed wire fence from the stems.</p>	20+	B2

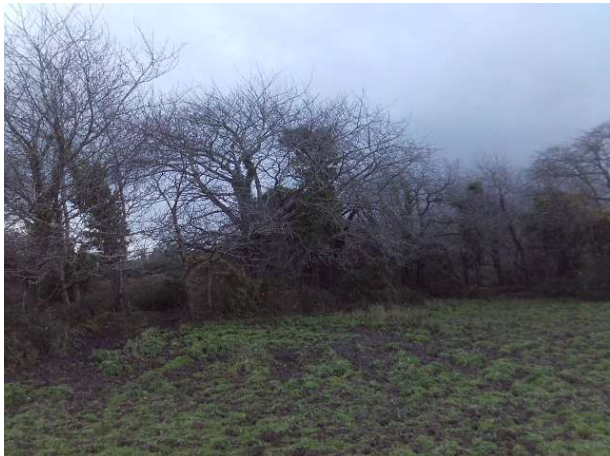
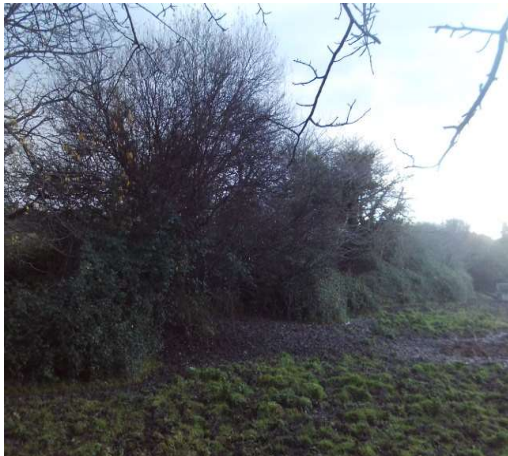
</div>	Ht. (m)	Stem Dia.(mm)	Branch Spread (m)	C-Ht. (m)	A6	-	A.6	-	It would benefit from general tidying works. Trim in encroaching hedge species. Carry out pruning and infill planting to create a better structured hedge.	B2
Ht. (m)	Stem Dia.(mm)	Branch Spread (m)	C-Ht. (m)															
A6	-	A.6	-															
The following trees are located in a line at the eastern end of this hedge.																		
0958 – 0983	Flowering Cherry <i>Prunus avium</i>	A.9	A. 350	A. 5N 6S	A. 2	Nature	Fair	Fair They extend along the site side (north) of Hedge No.20 and form parts of its higher bulking. The	Make safe dead/unstable growth.	20+	B2

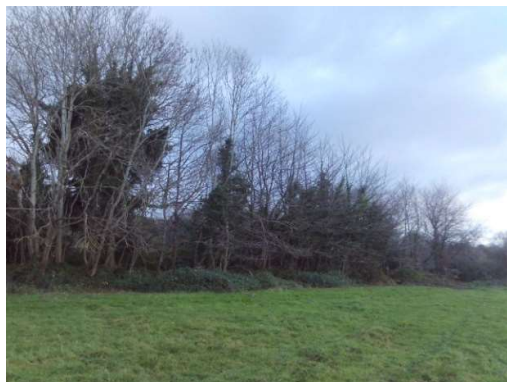
Ht. (m)	Stem Dia.(mm)	Branch Spread (m)	C-Ht. (m)															
		A6	-	A.6	-															
The following trees are located within this hedge.																				
1438-1443	Flowering Cherry <i>Prunus avium</i>	A12	A250	AN5 AS5 AE5 AW5	A2	Early Mature	Fair/ Good	Fair They are located along the southern boundary of the site area in a line. They are growing on the hedgerow bank and are multiple- stemmed from base. They are all growing up together forming part of the one group/ canopy formation and the higher canopy of this hedge. Ivy cover on some stems is beginning to extend up into their crowns. They have suffered damage caused by the livestock sheltering/ grazing within this area.	Cut Ivy at ground level where it is heavy on the trees. Tidy up the undergrowth and make safe large dead/unstable growth.	20+	B2

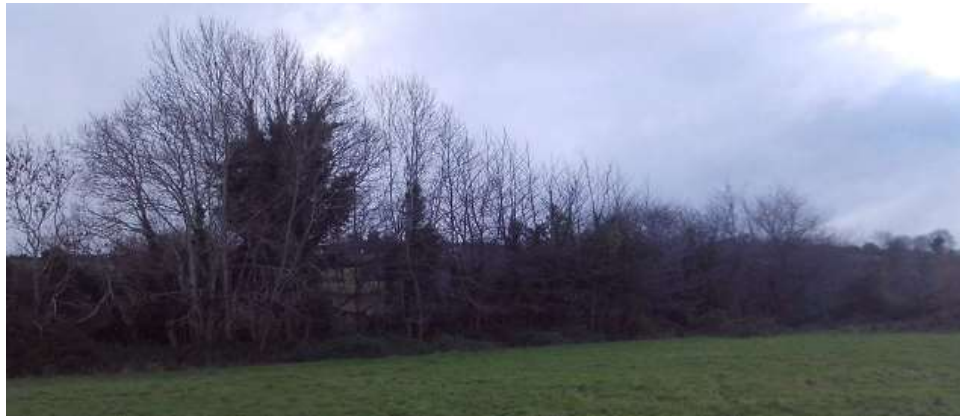
Ht. (m)	Stem Dia.(mm)	Branch Spread (m)	C-Ht. (m)														
		A4.5	A160X3 STEMS	A4E,4W	--														
The following trees are located within this hedge working from east to west.																			
1463-1470	Cherry <i>Prunus sp.</i>	A12	A400	A4N 4S 4E 4W	A1.5	Early Mature/ Mature	Fair	Fair It consists of a short line of Cherry trees with some Ash mixed throughout. They are growing on the hedge bank and forms part of the higher canopy within the hedge. They bulk of them are multiple-stemmed from base with deadwood throughout their crowns. Some stems are being suppressed by Ivy. They have suffered damage	Make safe large size dead/ unstable growth. Cut Ivy at ground level where it is heavy on the trees. They would benefit from general tidying works.	20+	B2

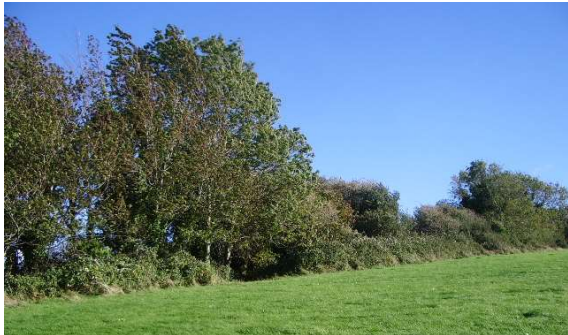
</div> <table><tr><td>A4</td><td></td><td>A3E, A3W</td><td>-</td></tr></table> <p>The following trees are located within this hedge.</p>							A4		A3E, A3W	-			
A4		A3E, A3W	-												
Tree Line No. 7	<p>Wild Cherry <i>Prunus avium</i></p> <p>Ash <i>Fraxinus excelsior</i></p>	<p>It is located at the northern end of Hedge No.24.</p> <p>It consists of a group of early mature trees in fair condition both physiologically and structurally. They have grown up together above the general hedge height with a combined canopy. They are a mix of single and multi-stem trees located mostly on the eastern side of the drainage ditch with some on western side. They form an upper storey in this part of the hedge. They have been drawn up and out for light, affecting their structure. There is damage to the lower main stems of some of the trees, most likely due to grazing animals.</p> <table><tr><td>A12</td><td>A200 (3 stems)</td><td>A5N, A5S, A5E, A5W</td><td>A 1.5</td></tr></table>							A12	A200 (3 stems)	A5N, A5S, A5E, A5W	A 1.5	<p>They are best managed in the group environment.</p> <p>Tidy up undergrowth.</p>	20+	B2

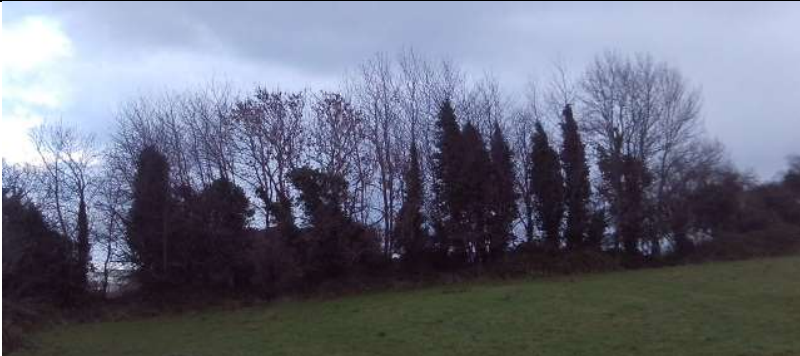
1980	Ash <i>Fraxinus excelsior</i>	14	260/ 450/ 340/ 300/ 210	5N 7S 3E 7W	4	Mature	Fair	Fair A multi-stem tree from low down with an acute union formation between the stems. It is growing on the western side of the ditch. The south stem divides at c.1.6m up into several stems. Ivy growth is extending up into the crown, increasing the wind sail. It has been drawn up and out for light affecting its structure. The crown contains minor deadwood with early signs of infection by 'Ash Dieback' (<i>Hymenoscyphus fraxineus</i>) evident.	Cut Ivy at ground level at present. Monitor its condition particularly infection by 'Ash Dieback' and manage accordingly.	10+	C1

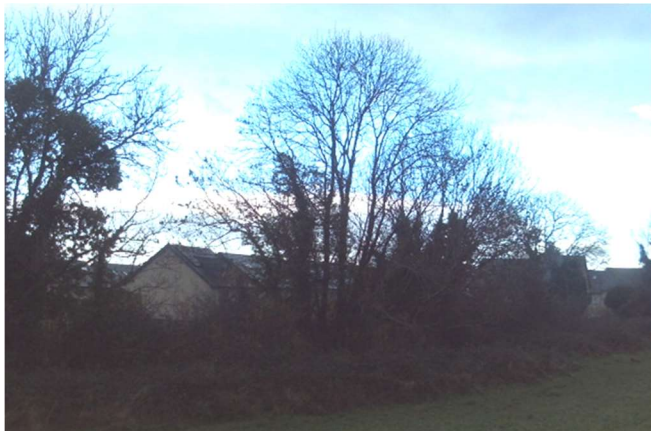
<table><tr><th>Ht. (m)</th><th>Stem Dia.(mm)</th><th>Branch Spread (m)</th><th>C-Ht. (m)</th></tr><tr><td>A4</td><td>--</td><td>A3N, 3S</td><td>--</td></tr></table> The following trees are located within Hedge No.25.							Ht. (m)	Stem Dia.(mm)	Branch Spread (m)	C-Ht. (m)	A4	--	A3N, 3S	--	Trim in encroaching hedge species to contain width of hedge and prune to reduce height on structurally weak sections of hedge. Cut Ivy at ground level where suppressing the hedge plants to less risk of wind damage.		C2
Ht. (m)	Stem Dia.(mm)	Branch Spread (m)	C-Ht. (m)																
A4	--	A3N, 3S	--

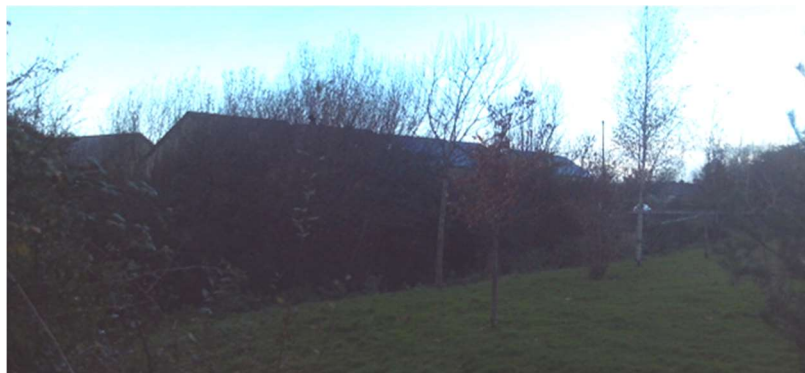
Hedge No.27A	Hawthorn <i>Crataegus monogyna</i> Elder <i>Sambucus nigra</i> Bramble <i>Rubus fruticosus</i> Goat Willow <i>Salix caprea</i> Dogrose	It runs an angle from Hedge No.25 and 26 in an east west direction and form the northern boundary of this site area to connect to Hedge No.22. It is of a mature age class in fair condition both physiologically and structurally. The main hedge line would appear to be located on the northern side of a wet drainage ditch and the main hedge species consists of clumps of Hawthorn, Elder, Blackthorn and Goat Willow with infill areas of Bramble and Dogrose and due to lapsed management, Bramble and Dogrose are encroaching out on either side creating a broader hedge. Ash and Goat Willow form part of the higher bulk of the hedge and some of Goat Willow is of a size where it is starting to break apart and this is broadening out this section of hedgerow.							Trim in all encroaching hedge species and cut back poorly structured sections of hedge to re-establish and create a better structured hedge.	B2

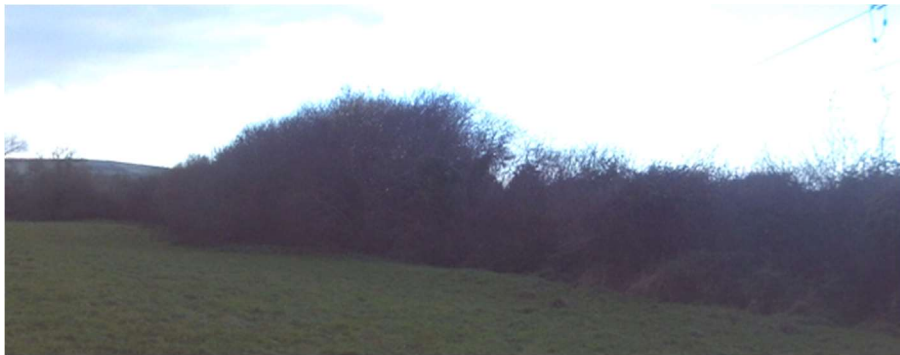
Hedge No.27B	Hawthorn <i>Crataegus monogyna</i> Elder <i>Sambucus nigra</i> Bramble <i>Rubus fruticosus</i> Goat Willow <i>Salix caprea</i> Dogrose <i>Rosa canina</i> Blackthorn <i>Prunus spinosa</i>	<p>It extends westwards from Hedge No.27A and at ninety degrees to Hedge No.22 to connect up with Hedge No.19. It runs a long part of the northern boundary of the site area.</p> <p>It is of a mature age class in fair condition both physiologically and structurally. The main hedge line would appear to be located on the northern side of a wet drainage ditch and the main hedge species consists of some clumps of Hawthorn, Elder and Goat Willow with infill areas of Bramble and Dogrose. There is some vegetation established on the site side of this ditch also. Due to lapsed management, Bramble and Dogrose are encroaching out on either side creating a broader hedge.</p>								Trim in all encroaching hedge species and cut back poorly structured sections of hedge to re-establish and create a better structured hedge.	C2

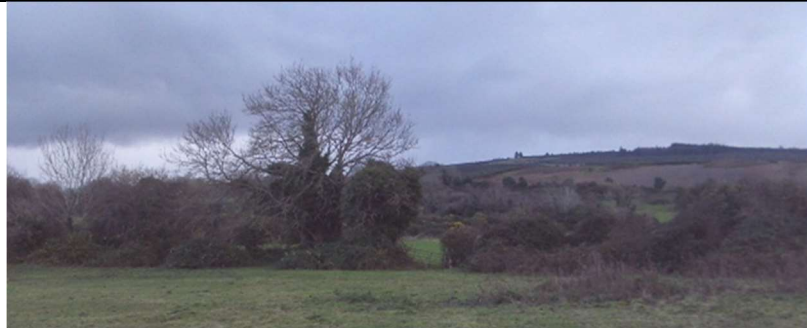
<p>The following trees are located within this hedge.</p>									
1922	Ash <i>Fraxinus excelsior</i>	16	500/ 430/ 210	6N 6S 6E 6W	2	Mature	Fair	Fair It is a large twin-stemmed tree from near base with other secondary stems also developing from its lower trunk. There are small decay pockets present where the lower limbs/ branches have been cut back or broke out in the past. Some soil erosion has been caused around its base by the livestock sheltering/ grazing within its crown spread. It has a broad crown and is a prominent, visual tree due to its isolation. Ivy cover on the main trunk is extending up into its crown. Its crown is relatively full and showing minor signs of 'Ash Dieback'.	Cut Ivy at ground level and tidy up the area around its base.	10+	C1
