An Arboricultural Assessment of the Tree Vegetation on the 'Oldcourt LRD Lands', Ballycullen & Oldcourt, Dublin 24.

Prepared for: Capami Ltd.

**Prepared by: Felim Sheridan F. Arbor. A, RFS Dip, Nat. Dip & NCH in
Arboriculture**

Date: 8th December 2023

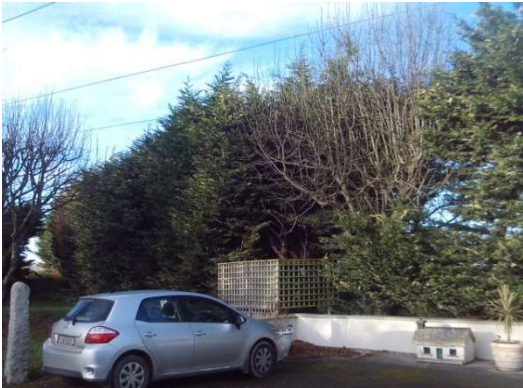
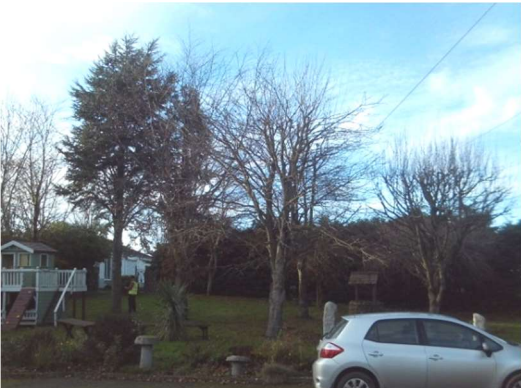
Tree No.	Tree Species	Ht. (m)	Stem Dia. (mm)	Branch Spread (m)	C-Ht. (m)	Age Class	Phys. Con.	Structural Condition Other Comments	Preliminary Recommendation	Remain Contribute in years	Cat. Grade
								N-north S-south E-east W- west Phys.-physiological.	A- average		
1416	Norway Maple cv. <i>Acer platanoides cv.</i>	8	370	N3 S3 E4 W3	2	Early Mature	Fair/ Good	Fair It is located underneath the overhead utility lines and has been heavily pruned/ reduced continuously in order to maintain clearance with a new crown developing from the pruning points.	It will require ongoing maintenance works if maintained within this location. My preferred management option would be to remove this tree completely as part of management.	<10	U
1417	Norway Maple cv. <i>Acer platanoides cv.</i>	9	450	N4 S5 E5 W5	2	Early Mature	Fair/ Good	Fair Its crown size has been reduced again due to its close proximity to the overhead utility lines with a compact crown of re-growth developing. The lower branches have also been removed previously in order to raise up its crown. It forms a twin-stemmed tree from 1.6m up with an acute union formation between stems.	Requires no work at the present time.	20+	B1

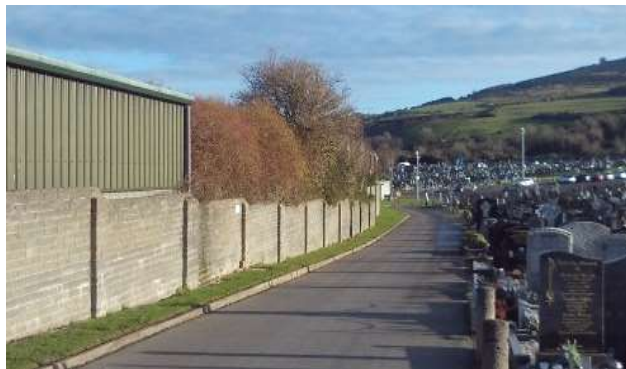
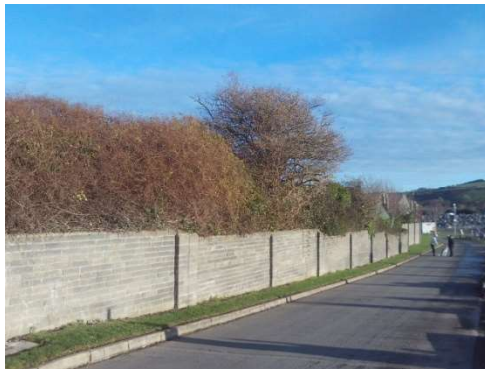
Hedge No.11	Leyland Cypress <i>Cuprocyparis leylandii</i>	<p>It is located along the north side of the boundary wall with the Cemetery grounds.</p> <p>It is of a mature age class in poor condition both physiologically and structurally.</p> <p>It consists of vegetation growing within a confined space between the boundary wall and the buildings.</p> <p>It contains some cut down Leyland Cypress trees at the eastern end with mainly naturally self-generating scrub species such as Elder, Bramble and Clematis. It has been trimmed on the cemetery side in order to contain.</p> <p>This is not an ideal location for vegetation; however it is of some value for screening.</p>							Continue present maintenance.	C2

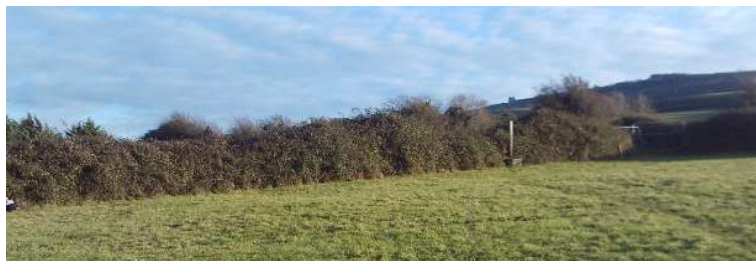
Hedge No.14	Hawthorn <i>Crataegus monogyna</i> Elder <i>Sambucus nigra</i> Bramble <i>Rubus fruticosus</i> Dogrose <i>Rosa canina</i>	<p>It extends in an eastward's direction from the boundary wall of the cemetery and forms the boundary between the fields to the north and the cemetery lands to the south.</p> <p>It is of a mature age class in fair condition physiologically and in fair/ poor condition structurally. It consists of isolated clumps of Hawthorn and Elder with large infill areas of Bramble and Dogrose. It is losing its hedge structure due to lapsed management with hedge species such as Bramble and Dogrose encroaching out onto the lands creating a broad scrubby hedge. The hedge plants are also structurally poor due to lapsed management.</p>

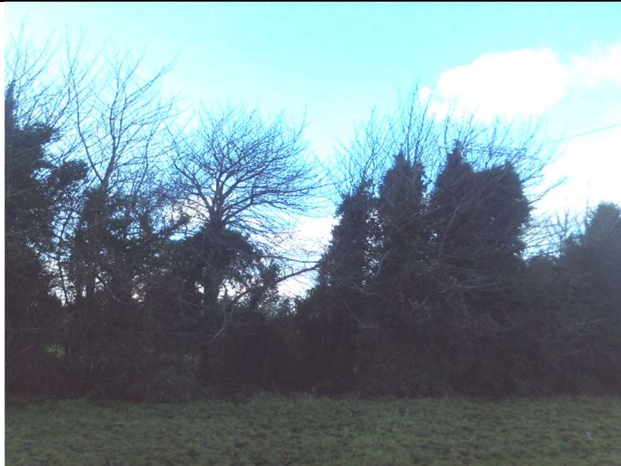
Hedge No.28	Hawthorn <i>Crataegus monogyna</i> Elder <i>Sambucus nigra</i> Bramble <i>Rubus fruticosus</i> Goat Willow <i>Salix caprea</i> Dogrose <i>Rosa canina</i> Goat Willow	It extends northwards from Hedge Nos. 17 and 27B to connect up with Hedge No.15 and it forms part of the site boundary and currently the boundary between two fields. It is of a mature age class in fair condition both physiologically and structurally. The main hedge line would appear to be located on the eastern side of a wet drainage ditch and the main hedge species consists of clumps of Hawthorn, Elder, and Goat Willow with infill areas of Bramble and Dogrose. There is some vegetation established on the western side of this ditch also. Due to lapsed management, Bramble and Dogrose are encroaching out on either side creating a broader hedge. Livestock sheltering/grazing within this area have caused some damage to this hedge. Forming the upper canopy of this hedge is a wide line of Flowering Cherry trees and these from a prominent tree line in this area. These trees are of an early mature age class in fair condition physiologically and structurally.							Trim in all encroaching hedge species and cut back poorly structured sections of hedge to re-establish and create a better structured hedge. Make safe large dead/unstable growth.	B2
